| <input checked="" type="checkbox"/> Safety Recall<br><input type="checkbox"/> Field Campaign<br><input type="checkbox"/> Service Information<br><input type="checkbox"/> Product Improvement | <b><u>FIELD SERVICE BULLETIN</u></b><br><b><u>2006 TO Current GM G3500 AND</u></b><br><b><u>G4500 CHASSIS with 6.6L Diesel</u></b><br><b><u>engine</u></b><br><br><b><u>Electrical short</u></b> | <b>FSB_2017_1</b><br>June 2017<br><br>Contact: Carlton Allen<br>850-921-7373<br>callen@cutr.usf.edu |

**UNITS AFFECTED:** All 2006 to current GM G3500 and G4500 Chassis with a 6.6l diesel engine.

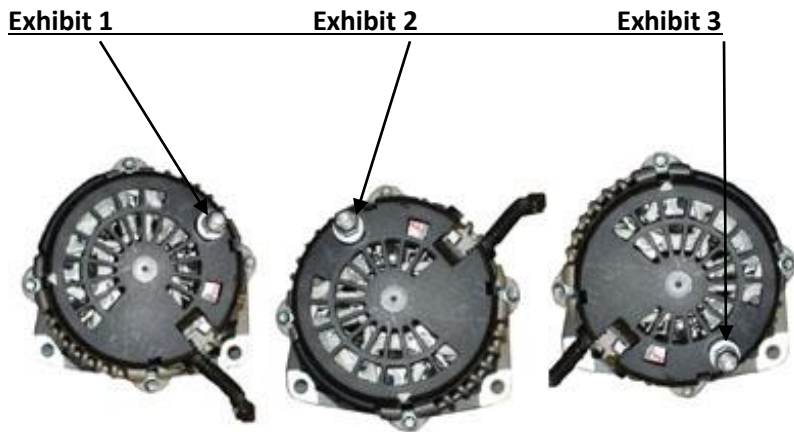
**DESCRIPTION:** The above stated chassis' that have an aftermarket alternator such as a Penn-Tex or KEI brand, has the potential for an electrical short circuit to occur if the battery cable connection stud is located incorrectly at the rear of the alternator.

**PROCEDURE:** To properly check the location of the battery cable connection stud, the air filter housing will need to be removed. Once the air filter housing is removed, verify that the battery cable connection stud is located as shown in **Exhibit 1**. If the battery cable stud is located as shown in **Exhibits 2 and 3**, the alternator will need to be replaced with the correct model for this application. An identification label is located under the hood of each bus listing the correct part number. If you are unable to locate the label you may contact the selling dealer to procure the proper replacement or to verify the correct part number. Each time an alternator is replaced proper battery cable routing and securement orientation should be verified using chart below.
