<input checked="" type="checkbox"/> Safety Recall <input type="checkbox"/> Field Campaign <input type="checkbox"/> Service Information <input type="checkbox"/> Product Improvement	<b>FIELD SERVICE BULLETIN</b> <b><u>2006 TO Current GM G3500 AND</u></b> <b><u>G4500 CHASSIS with 6.6L Diesel</u></b> <b><u>engine</u></b>  <b><u>Electrical short</u></b>	<b>FSB_2017_1</b> June 2017  Contact: Carlton Allen 850-921-7373 callen@cutr.usf.edu
--	---	---

**UNITS AFFECTED:** All 2006 to current GM G3500 and G4500 Chassis with a 6.6l diesel engine.

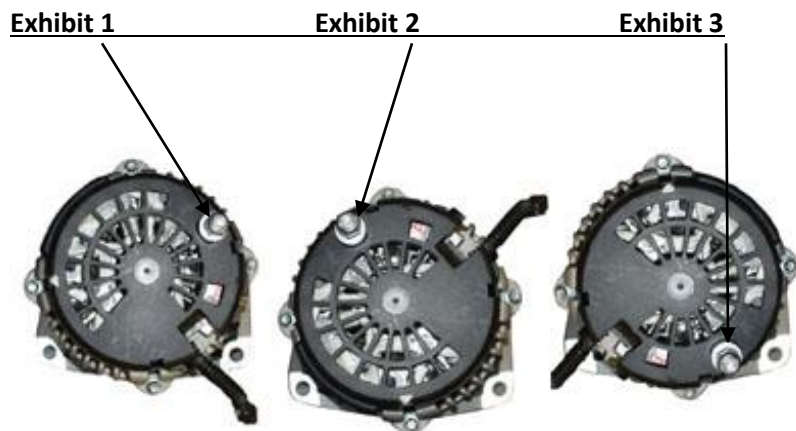
**DESCRIPTION:** The above stated chassis' that have an aftermarket alternator such as a Penn-Tex or KEI brand, has the potential for an electrical short circuit to occur if the battery cable connection stud is located incorrectly at the rear of the alternator.

**PROCEDURE:** To properly check the location of the battery cable connection stud, the air filter housing will need to be removed. Once the air filter housing is removed, verify that the battery cable connection stud is located as shown in **Exhibit 1**. If the battery cable stud is located as shown in **Exhibits 2 and 3**, the alternator will need to be replaced with the correct model for this application. An identification label is located under the hood of each bus listing the correct part number. If you are unable to locate the label you may contact the selling dealer to procure the proper replacement or to verify the correct part number. Each time an alternator is replaced proper battery cable routing and securement orientation should be verified using chart below.
