FMNA TECHNICAL SERVICE BULLETIN 160002

Subject: Piston Accumulator Gauge Leak

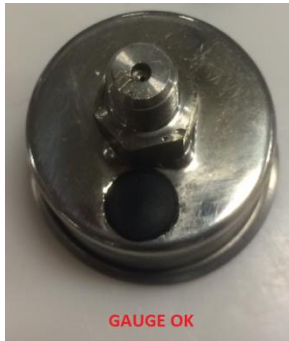
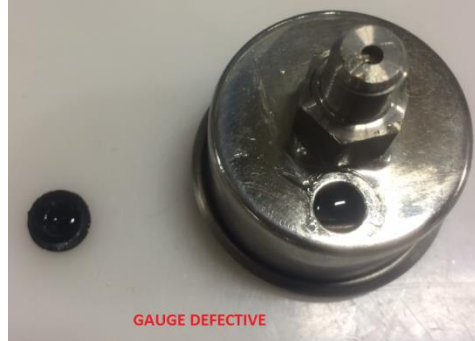
Problem: A small micro leak at the weld of the bourdon tube inside the glycerin filled Piston Accumulator pressure gauge slowly leads to an over pressurization inside the gauge housing and eventually pushes a small black rubber plug out of the back of the gauge. The glycerin also leaks out of the back of the gauge. This failure can occur after many months of service life.

Root Cause: Confirmation: The cause has been confirmed by FMNA engineering to be a leak at a small weld of the bourdon tube inside the gauge.

Corrective Action: Inspect all buses for signs of a defective gauge. A gauge can be deemed defective if the black rubber pressure relief plug has been pushed out of the back of the gauge as seen in the pictures below. It is important to note that a defective gauge does NOT affect the function or performance of the fire suppression system. The fire suppression system will still detect and suppress fires as normal.

Once inspection is complete, all defective gauges should be replaced with a redesigned version of the gauge and a new bonded sealing washer. This requires depressurizing the Piston Accumulator, replacing the gauge, and then re-pressurizing and should only be performed by technicians trained and certified by FMNA. Please contact FMNA customer service at (610)-265-3610 for a certified service technician contact. Repairs will be covered under warranty. Also, any service going forward that requires PA depressurization shall be accompanied with gauge replacement.
