FMNA TECHNICAL SERVICE BULLETIN 160002

Subject: Piston Accumulator Gauge Leak

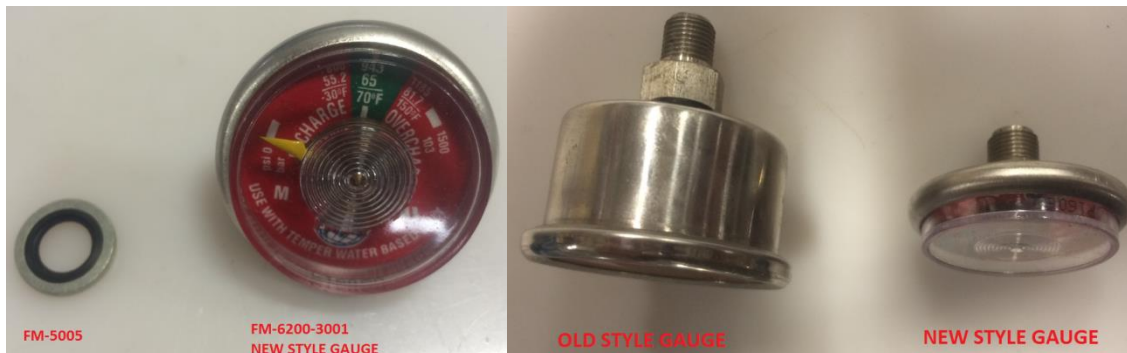
Problem: A small micro leak at the weld of the bourdon tube inside the glycerin filled Piston Accumulator pressure gauge slowly leads to an over pressurization inside the gauge housing and eventually pushes a small black rubber plug out of the back of the gauge. The glycerin also leaks out of the back of the gauge. This failure can occur after many months of service life.

Root Cause: Confirmation: The cause has been confirmed by FMNA engineering to be a leak at a small weld of the bourdon tube inside the gauge.

Once inspection is complete, all defective gauges should be replaced with a redesigned version of the gauge and a new bonded sealing washer. This requires depressurizing the Piston Accumulator, replacing the gauge, and then re-pressurizing and should only be performed by technicians trained and certified by FMNA. Please contact FMNA customer service at (610)-265-3610 for a certified service technician contact. Repairs will be covered under warranty. Also, any service going forward that requires PA depressurization shall be accompanied with gauge replacement.
